Page 3 of 45
1-C11-NSM-04.05
UNREVIEWED SAFETY QUESTION DETERMINATION
USQD Number: USQD-RFP-94.1186-BWW, Rev. 1

USQD TITLE: DEPARTMENT OF ENERGY, PLUTONIUM ES&H VULNERABILITY ASSESSMENT,
ROCKY FLATS SITE ASSESSMENT TEAM REPORT, July 29, 1994

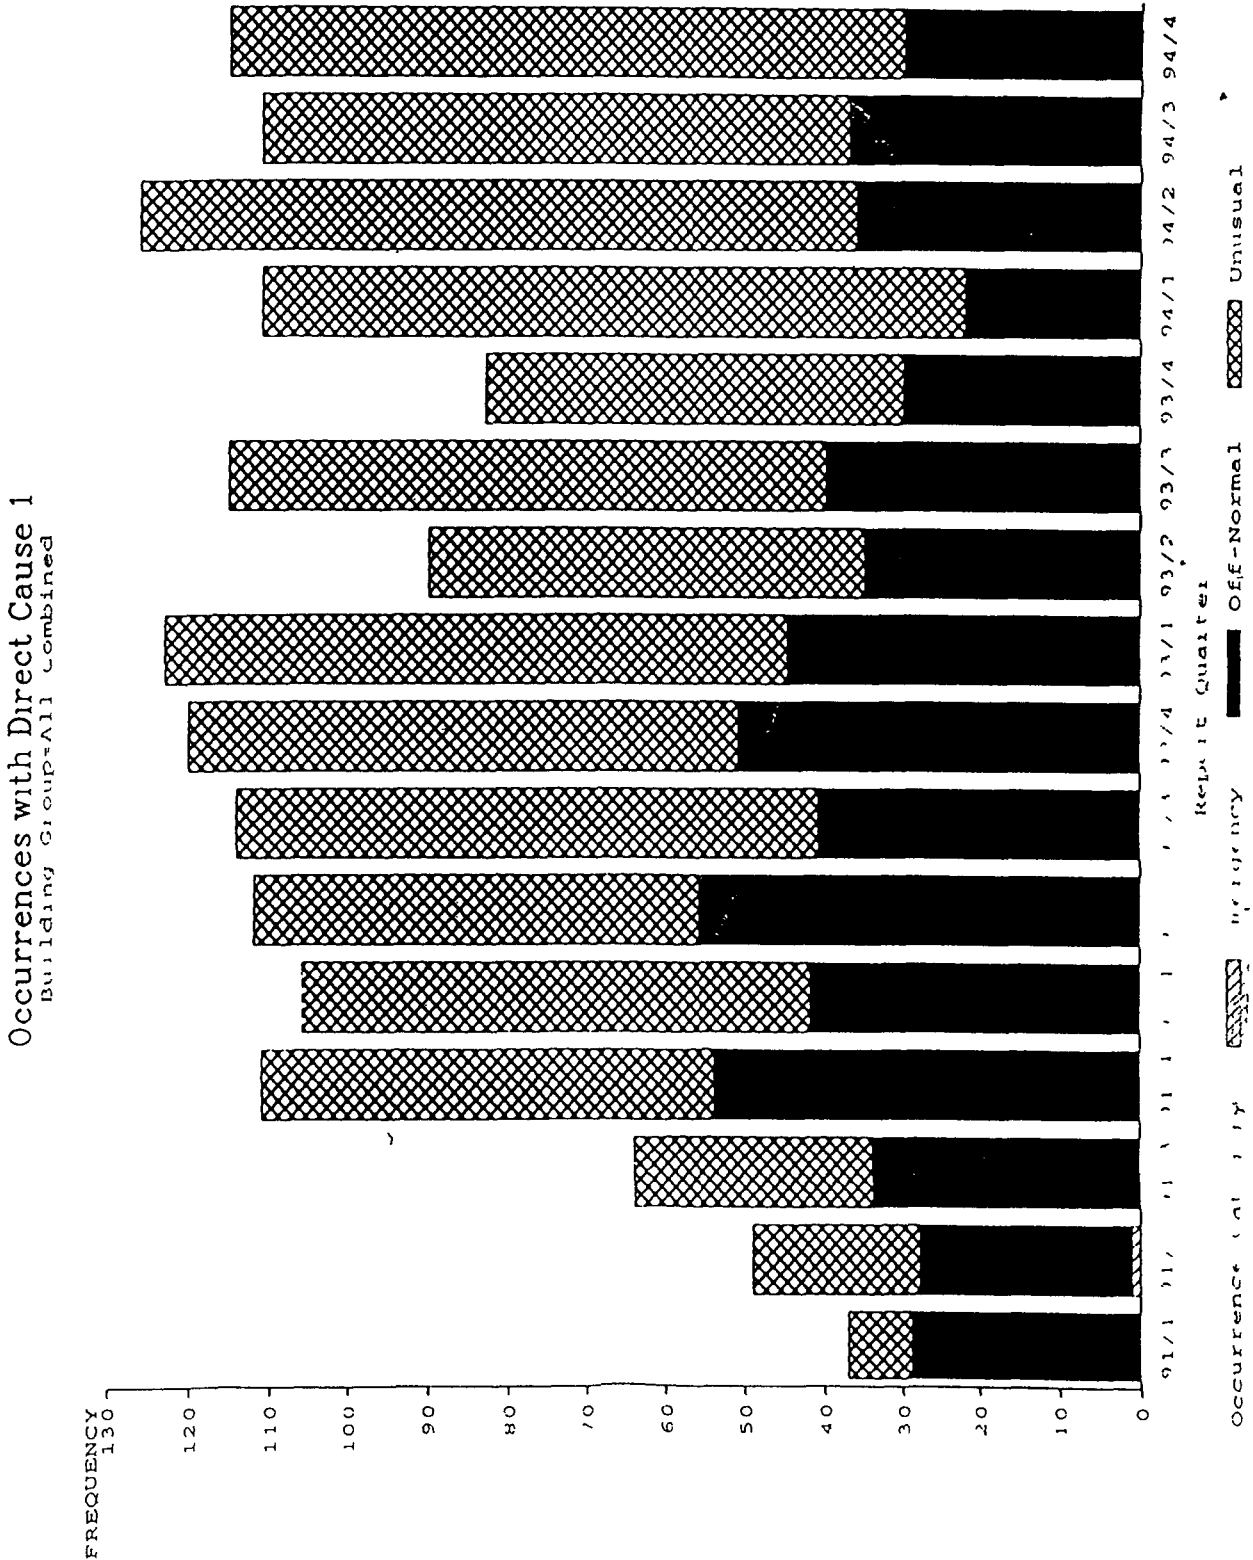
Direct Cause 1 is Equipment / Material Problem

Several data bases were searched to explore the extent of increasing failure rates. They are Occurrence Reports (ORs), Limit Conditions of Operation Tracking (LCOT), and Maintenance Work Control Forms (MWCFs). Histograms of the ORs from 1990 to 1994 do not indicate any overall trend. These histograms are in Attachment 2. LCOT data lists when a particular LCO is not met, however, the data does not identify a particular system or component that is causing the out-of-tolerance condition. Therefore, this data is not useful to this end. Histograms of MWCFs submitted by Building 707 and Building 771 are also include in Attachment 2. Several outside influencing factors are evident in the histogram for Building 707 MWCFs. These are mission change, resumption, and the decision to reduce the area within the building in which material is stored. An increasing trend is not identified in these histograms.

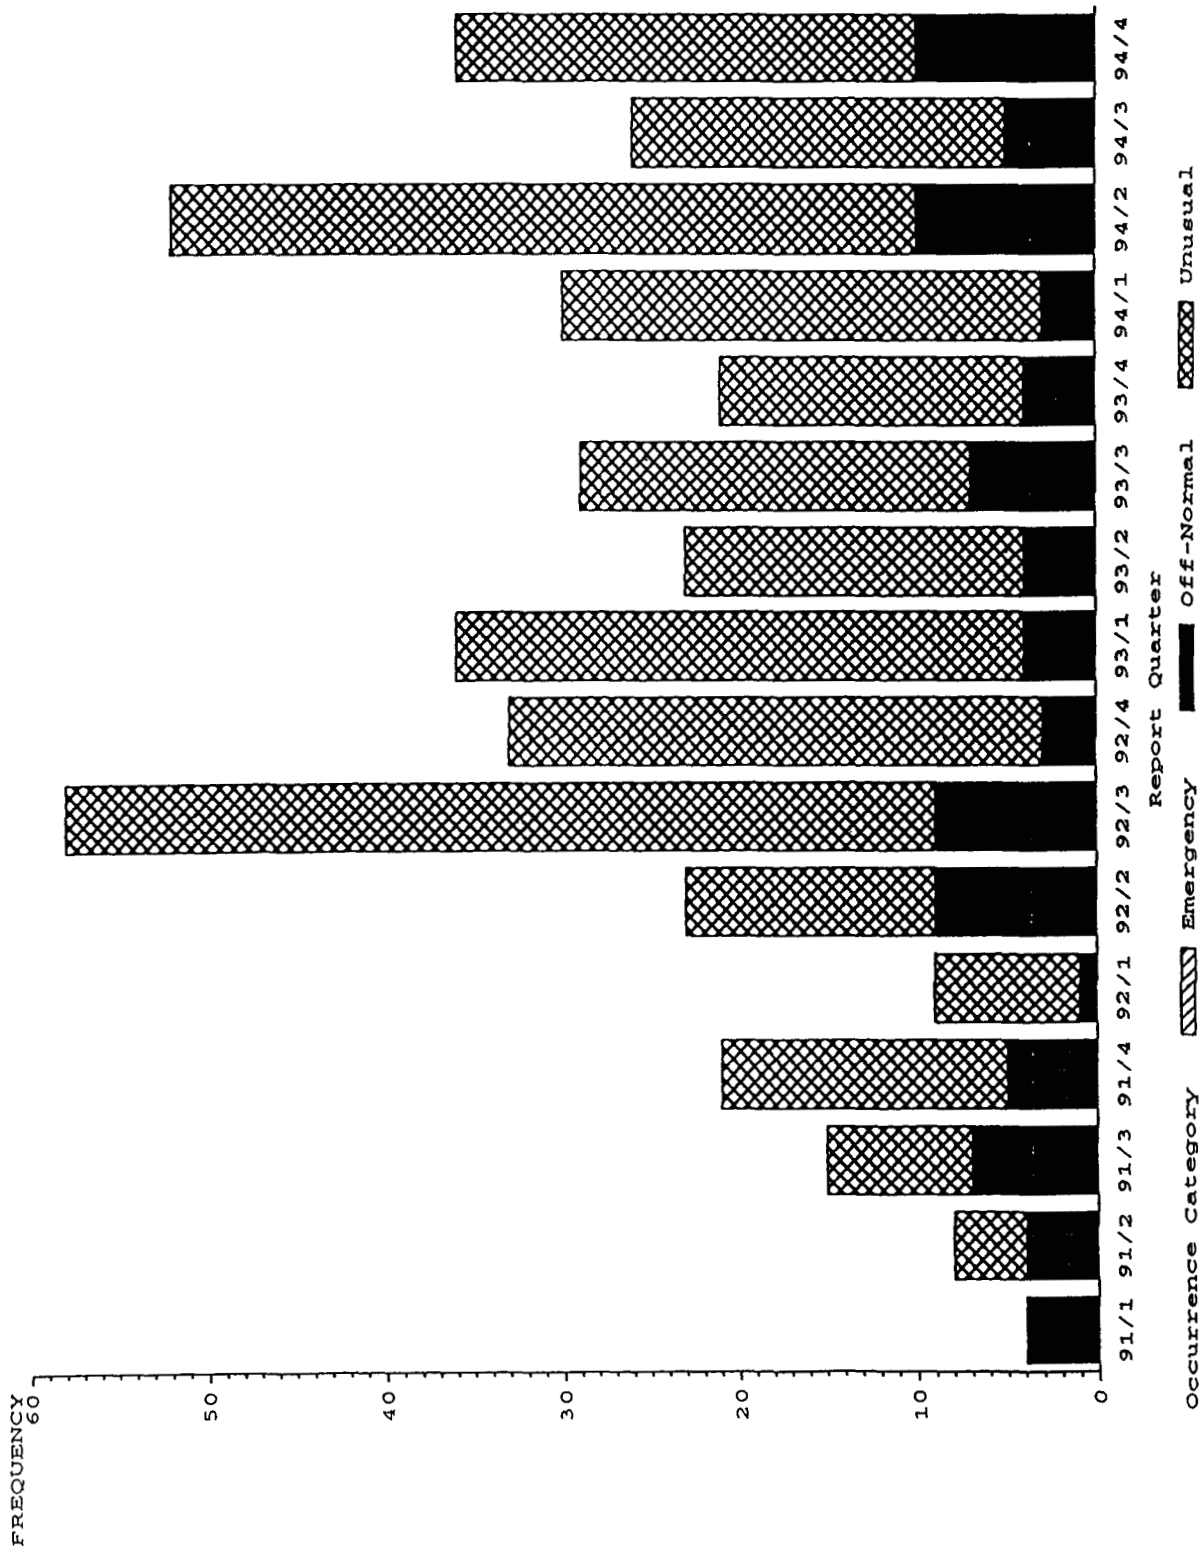
Building 707 Occurrences with Direct Cause 1A or 1B

Direct Cause 1A is Defective or Failed Part
 Direct Cause 1B is Defective or Failed Material

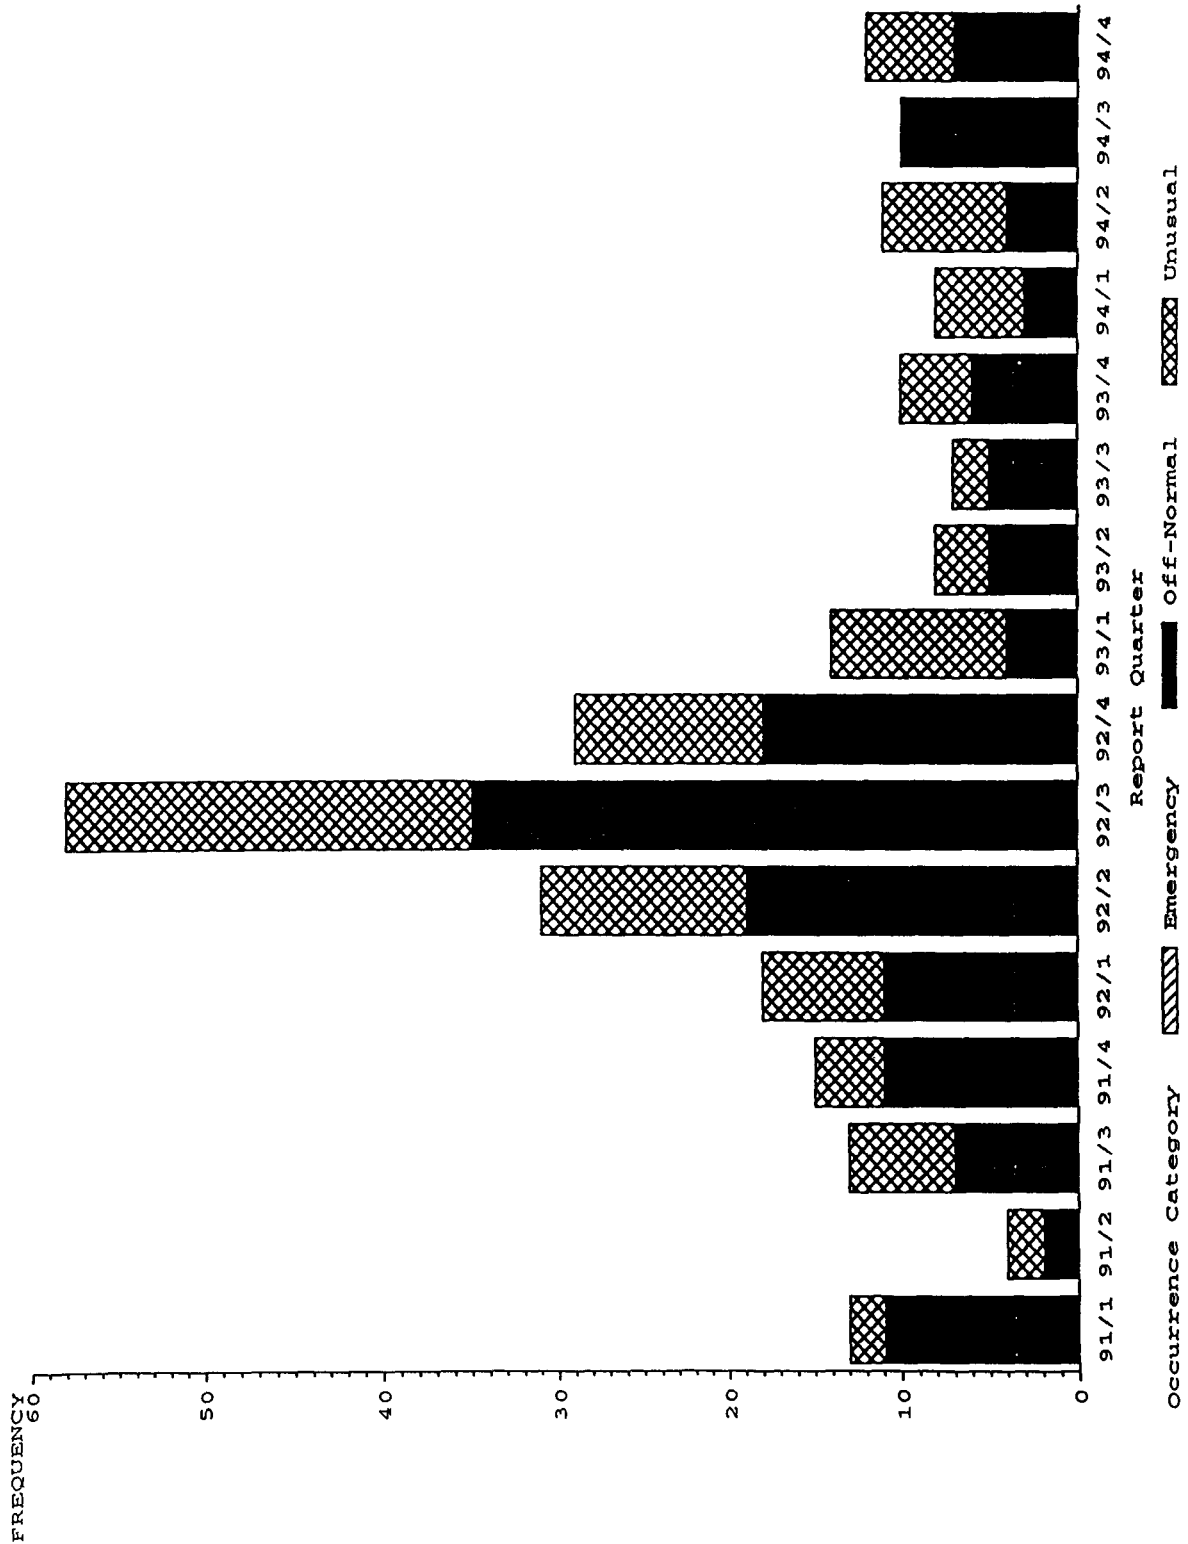
Building 707 Occurrences with Direct Cause 3

Direct Cause 3 is Personnel Error

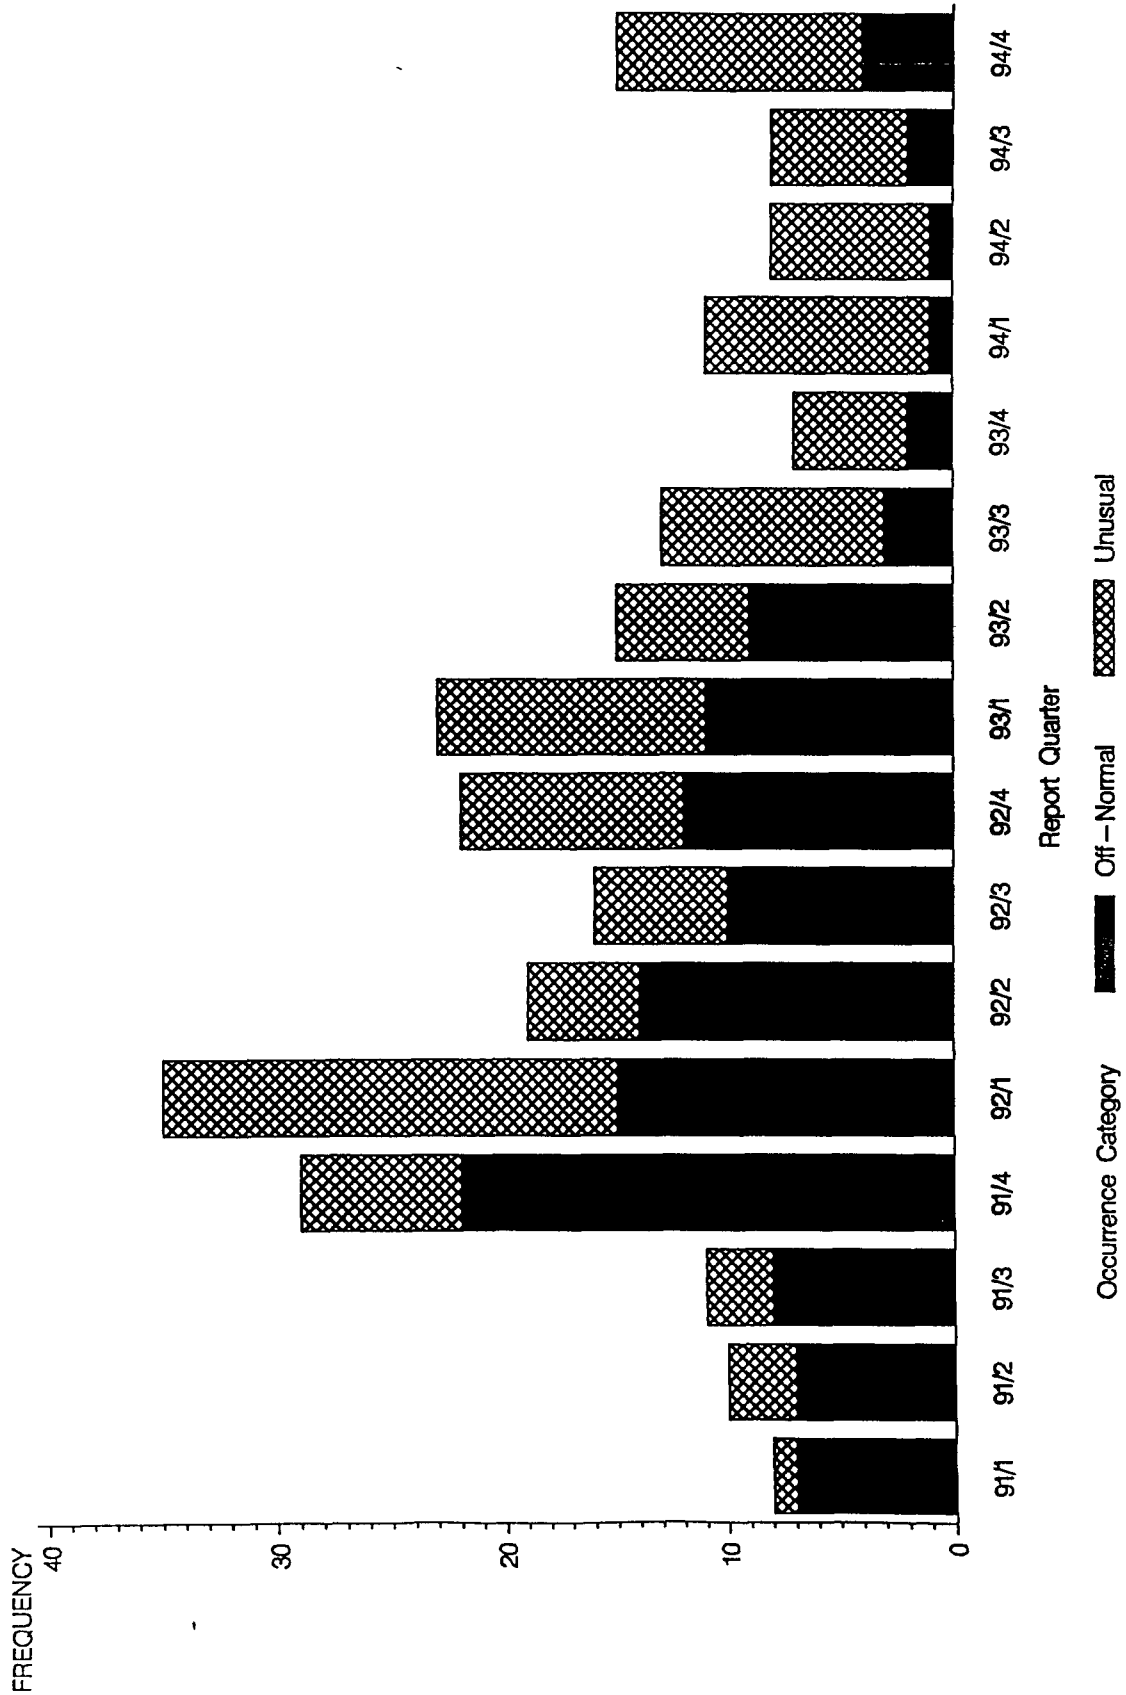
Building 771 Occurrences with Direct Cause 1

Direct Cause 1 is Equipment / Material Problem

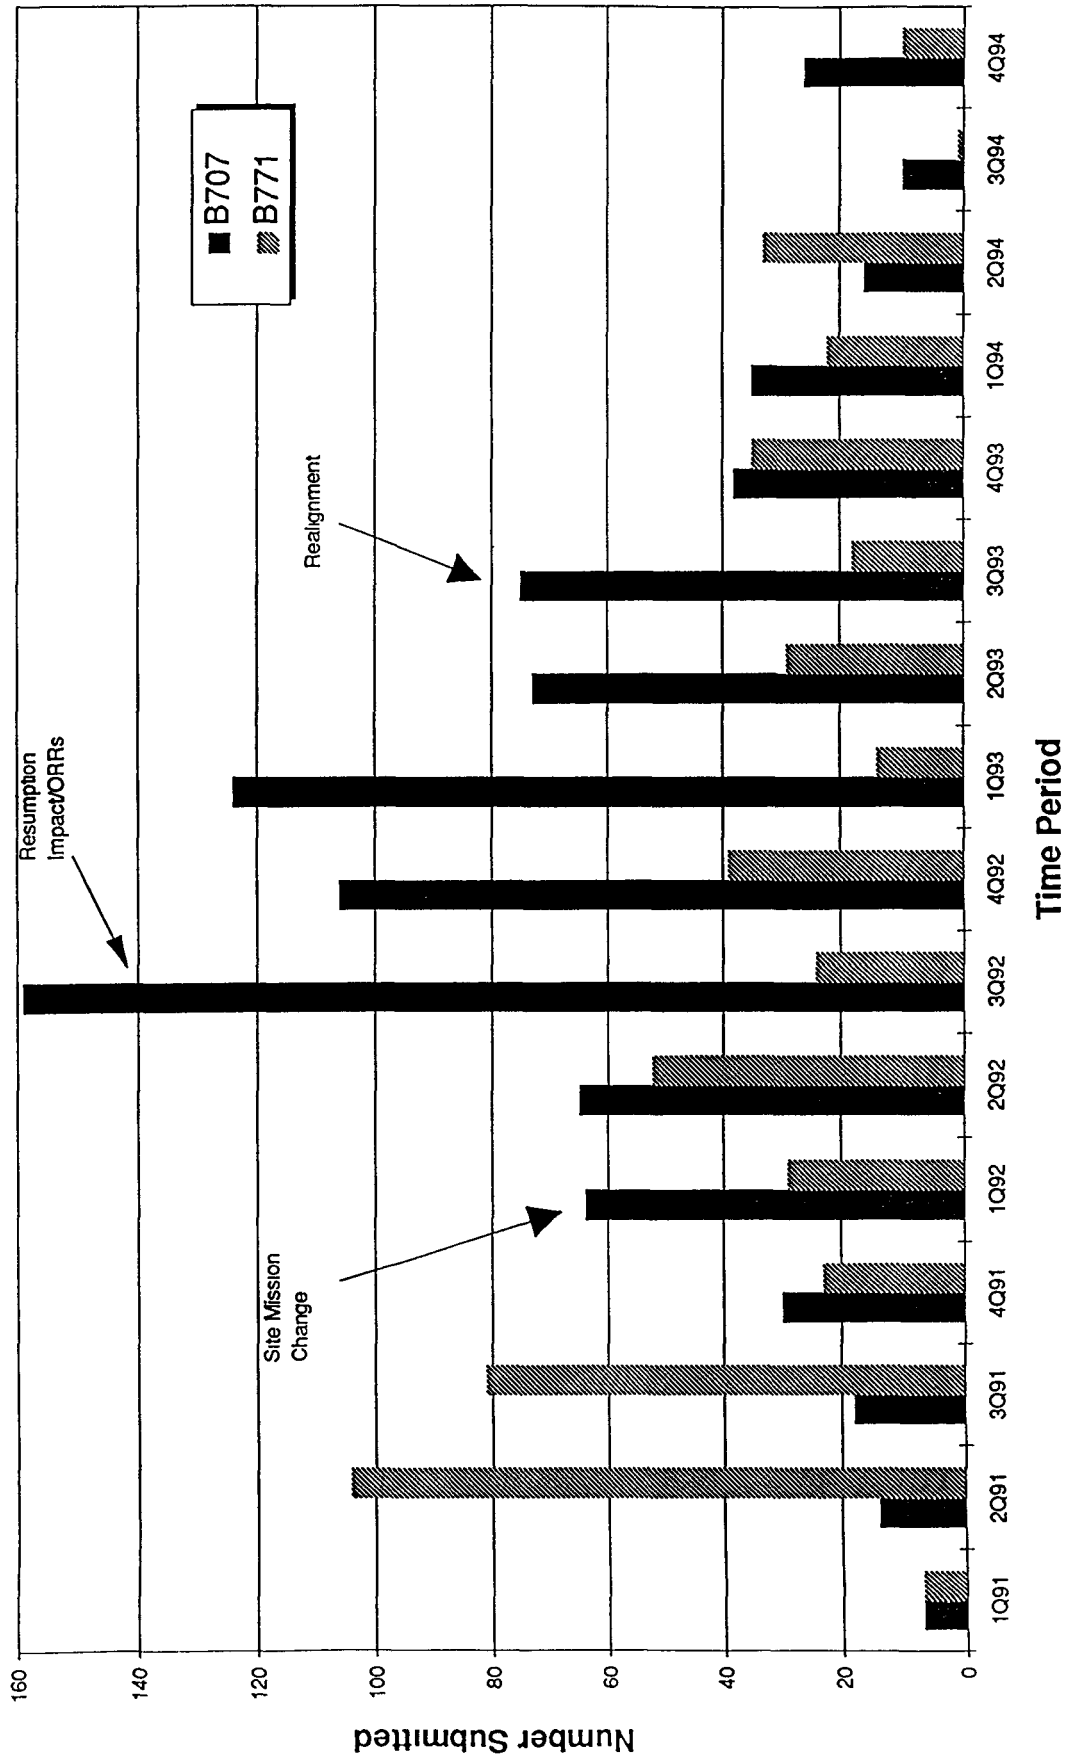
MWCFs Submitted for B707 & B771

Though an increasing trend in failure rate is not identified, a review of the MWCFs provide indications that some components are not operable requiring some type of compensatory measures. This is an indication that the system's functionality is not what it was originally assumed. The compensatory measure may be operating the component in a manual mode rather than automatic, or it may require some action such as fire watches. Examples of system degradation are provide below.
